Energy-efficiency Up-grade with Pre-fabricated Façade Elements – the Innova Project Renovation in Saturnuksenkatu 2, Riihimäki

Kimmo Lylykangas,
architect SAFA
Kimmo Lylykangas
Architects, Finland
*kimmo.lylykangas@
arklylykangas.com*

Summary

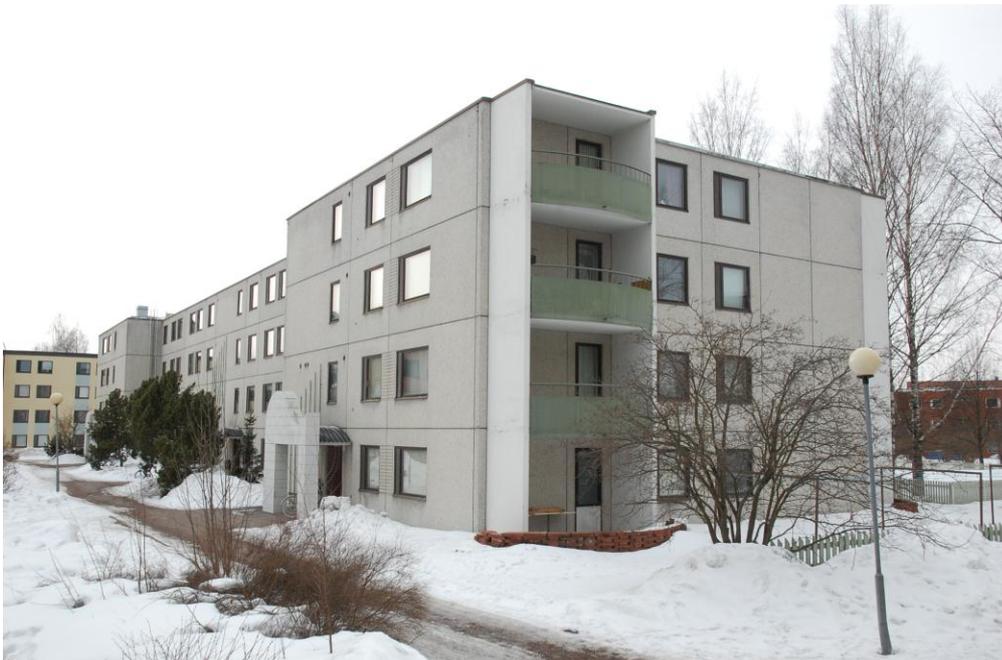
Fig. 1 The multi-storey house in Saturnuksenkatu 2, Riihimäki is retrofitted to meet the Finnish passive house requirement, i.e. the heating energy demand after the renovation is max. 25 kWh/m²a. Photo: Jari Kiuru.

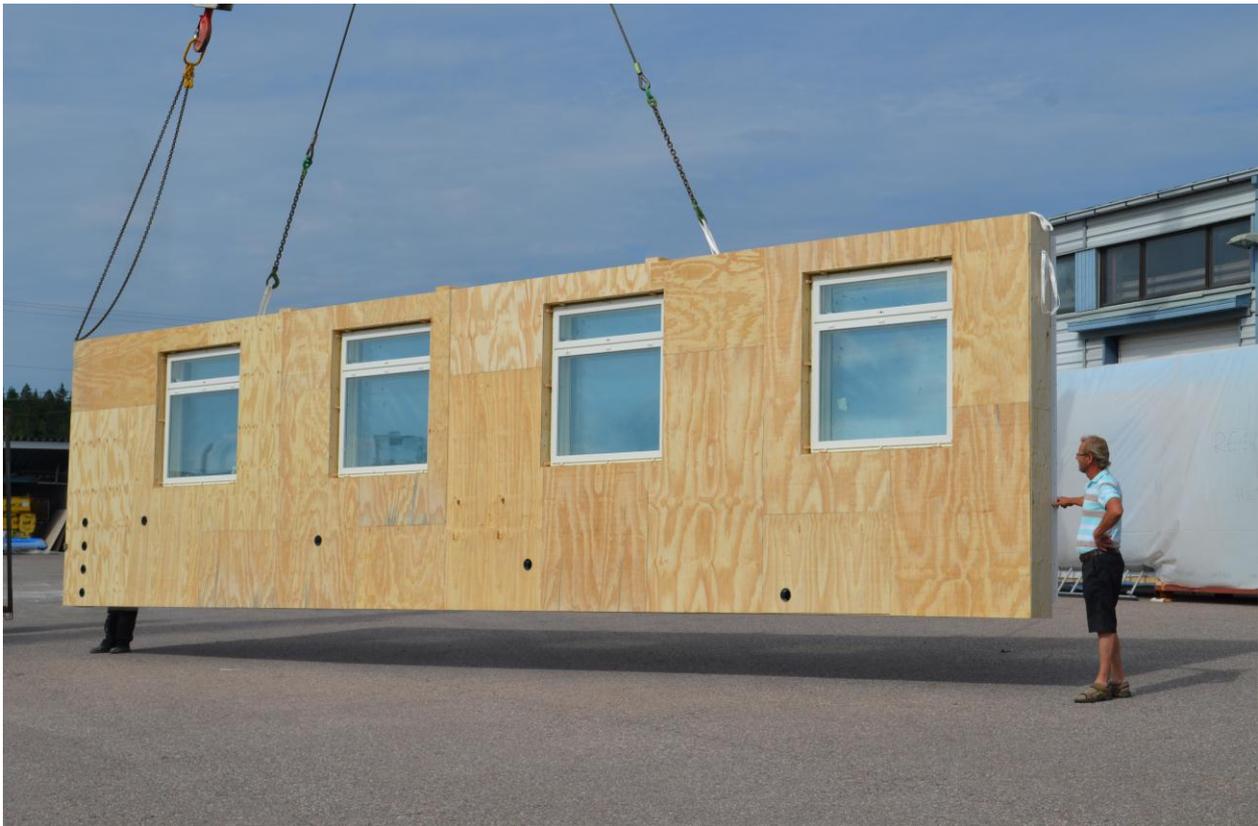
Fig. 3 The elements are transported in horizontal position and will be turned by the crane. The model element was tested at the element factory before the manufacturing was started. The round holes are the ventilation ductwork connections. Photo: Kimmo Lylykangas.

A model element was tested by lifting and turning before the manufacturing started. Neither the windows nor the first layer of the plaster rendering got damages in the lifting. The dimensional tolerance of the façade element is 4 mm.

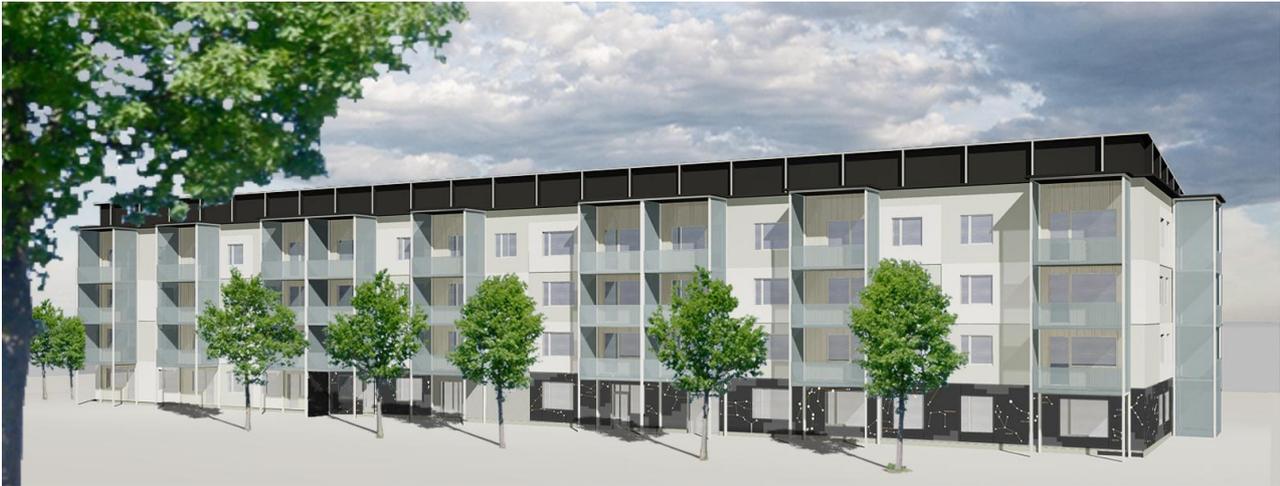
Fig. 5 The new façade materials are plaster rendering, cement fibre board (day-care centre) and wood cladding (balconies). The 3-dimensional surface of the plaster rendered facade and the variation of colour show the division of apartments behind the façade. The target of the architectural design was to upgrade the facades, but still maintain a connection to the original character of the building. Image: Kimmo Lylykangas Architects.

On the outside, mineral wool with plaster rendering was glued onto the cement fiber board. The façade material behind the balconies is wooden cladding with ventilation cavity behind it. The façade material of the day-care center in the ground floor is painted cement fiber board.
